| Subject | | <b>ENGINE HARD STARTING ISSUES</b> | |
| Effective date : | <b>05/05/2015</b> | Document number : | <b>CF2015-010T</b> |
| Vehicle(s) involved : | | <b>X550, X550 EPS.</b> | |

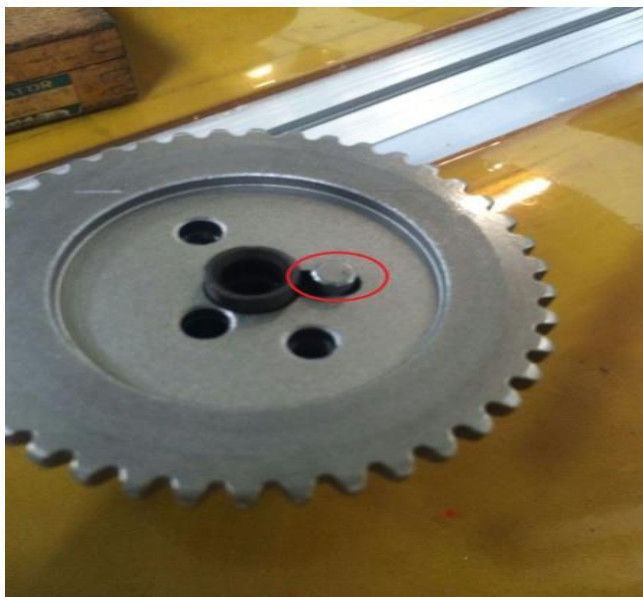
1. Remove the fuel tank outer top cover, instrument cowl, fuel tank, RH side engine cowl, drain coolant and remove top radiator hose, then remove the engine cylinder head cam cover.
2. Place a clean cloth or rag under the camshaft sprocket to reduce the likelihood of any objects falling inside the engine. Remove the camshaft decompressor 8mm centre bolt and remove the decompressor assembly from the end of the camshaft.
3. Once the decompressor assembly has been removed, inspect the locating pin and if it is protruding more than 0.5mm, it will cause the engine decompressor to jam and cause difficult starting.

### 1.Photo of faulty decompression locating pin.

4. Use a pin punch and lightly tap the camshaft chain sprocket locating pin inwards, until it is fully seated. ( you will hear and feel when the locating pin is fully seated).

5. Refit the decompressor assembly back into the camshaft , add thread locking agent to 8mm decomp mounting bolt and retension bolt to 30Nm. Operate the decompressor to ensure that the decomp weight moves freely through out its range to ensure it is not binding.

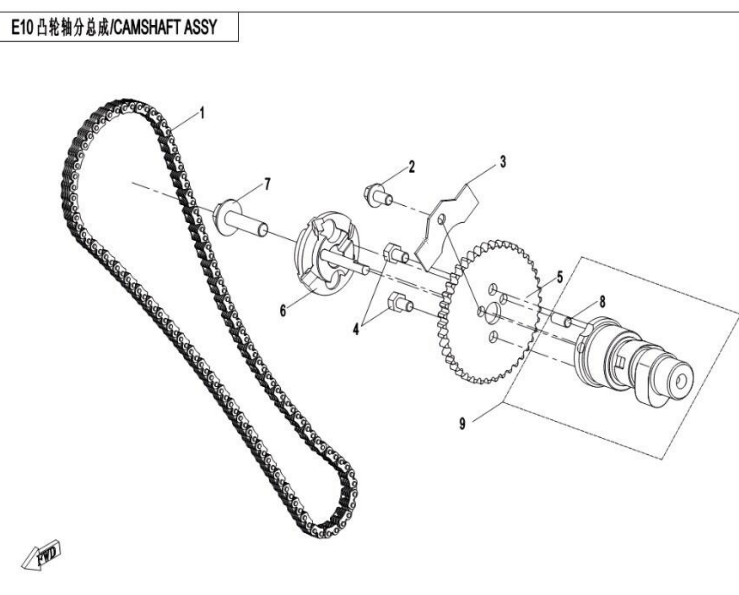
### 2. Camshaft decompressor assembly illustration

Dowl pin, sprocket., (item #8 in above parts illustration)
